Natural Resource Assessments in Afghanistan Supported by High Resolution Digital Elevation Modeling and Multi-spectral Image Analysis

USGS/USAID Natural Resource Assessments

Kajakai Dam and Spillway Level Increase: Location and Plan

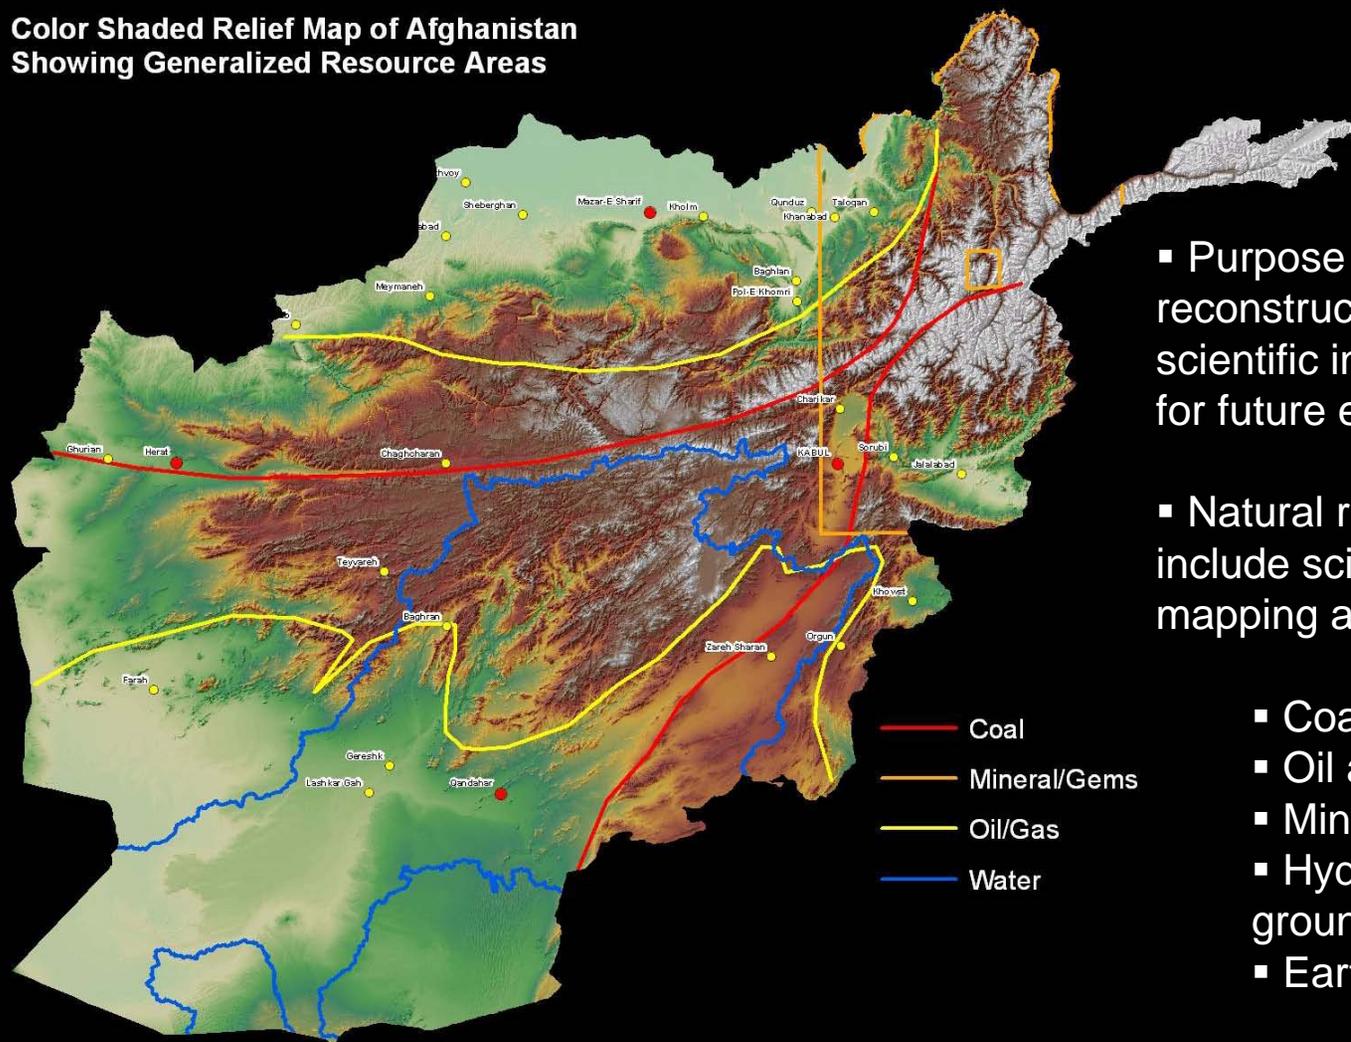
Color Shaded Relief Map of Afghanistan
Showing Generalized Resource Areas

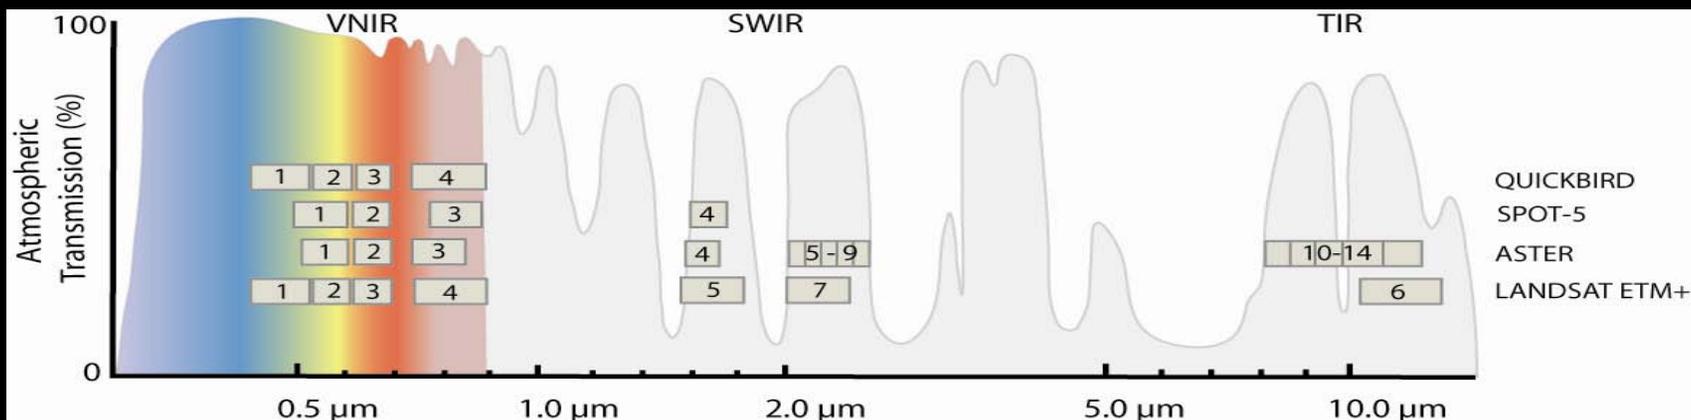
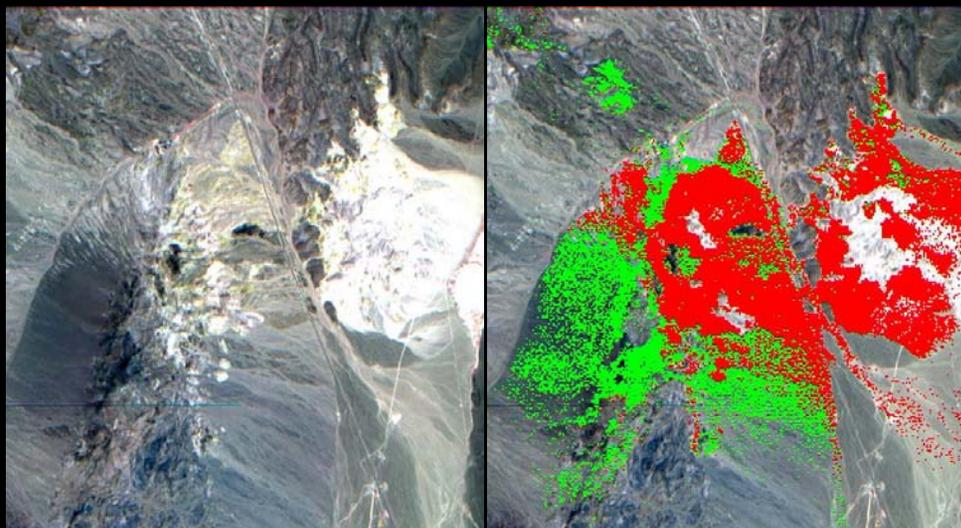
Spectral Resolution of Quickbird, Landsat 7 ETM+, and ASTER and band ratios used for mineral mapping

ASTER BAND RATIO AND RBD IMAGES

- B3/B2 - VEGETATION
- B2/B1 - Fe³⁺
- (B4+B6) / B5 - ALUNITE, KAOLINITE
- (B5+B7) / B6 - MUSCOVITE, SMECTITE-ILLITE, SERICITE
- (B7+B9) / B8 - CARBONATE, EPIDOTE, CHLORITE
- B14 / B12 - QUARTZ-RICH ROCKS

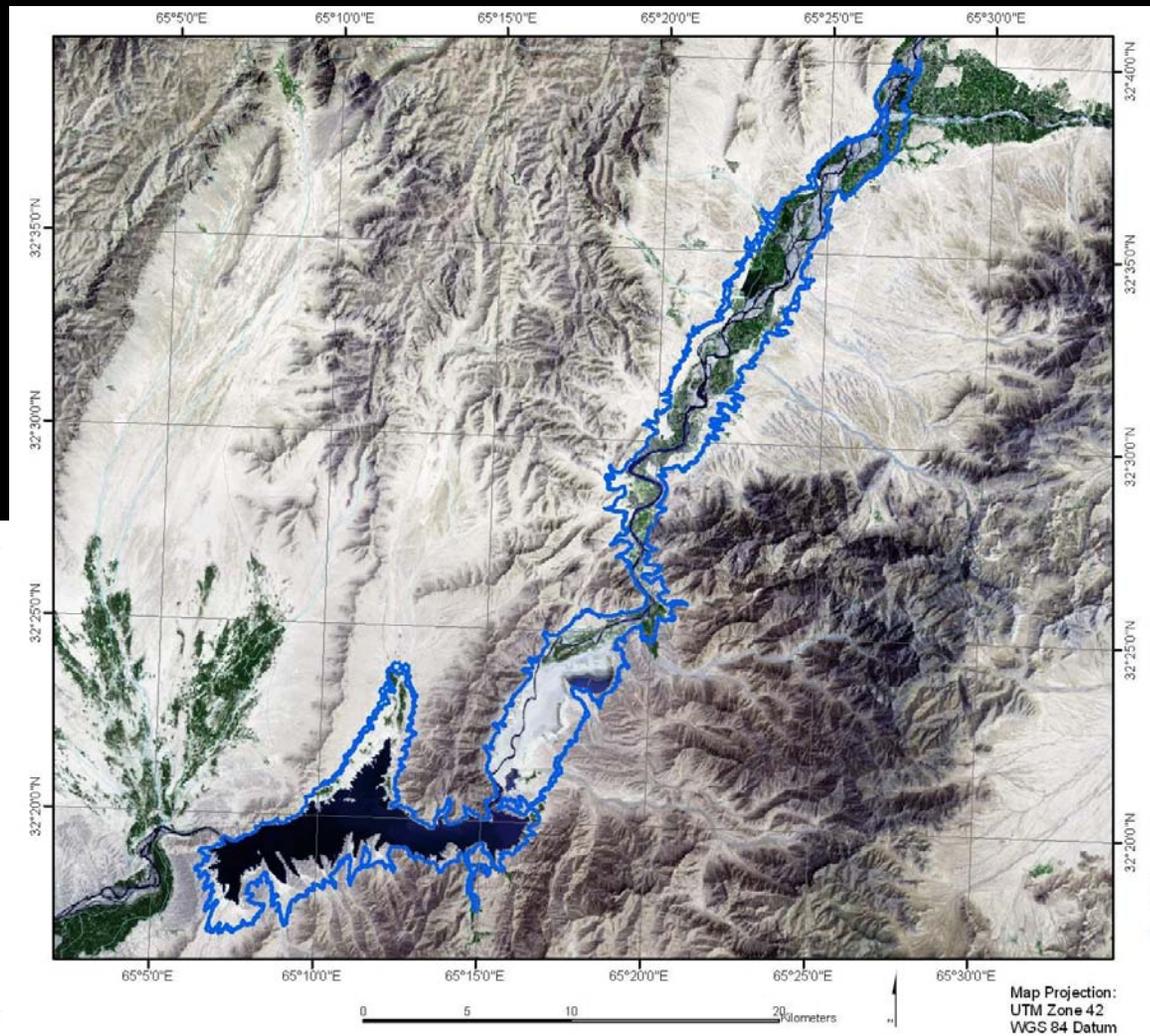
- Kajakai Dam and Reservoir in Helmand and Uruzgan Provinces, SW Afghanistan

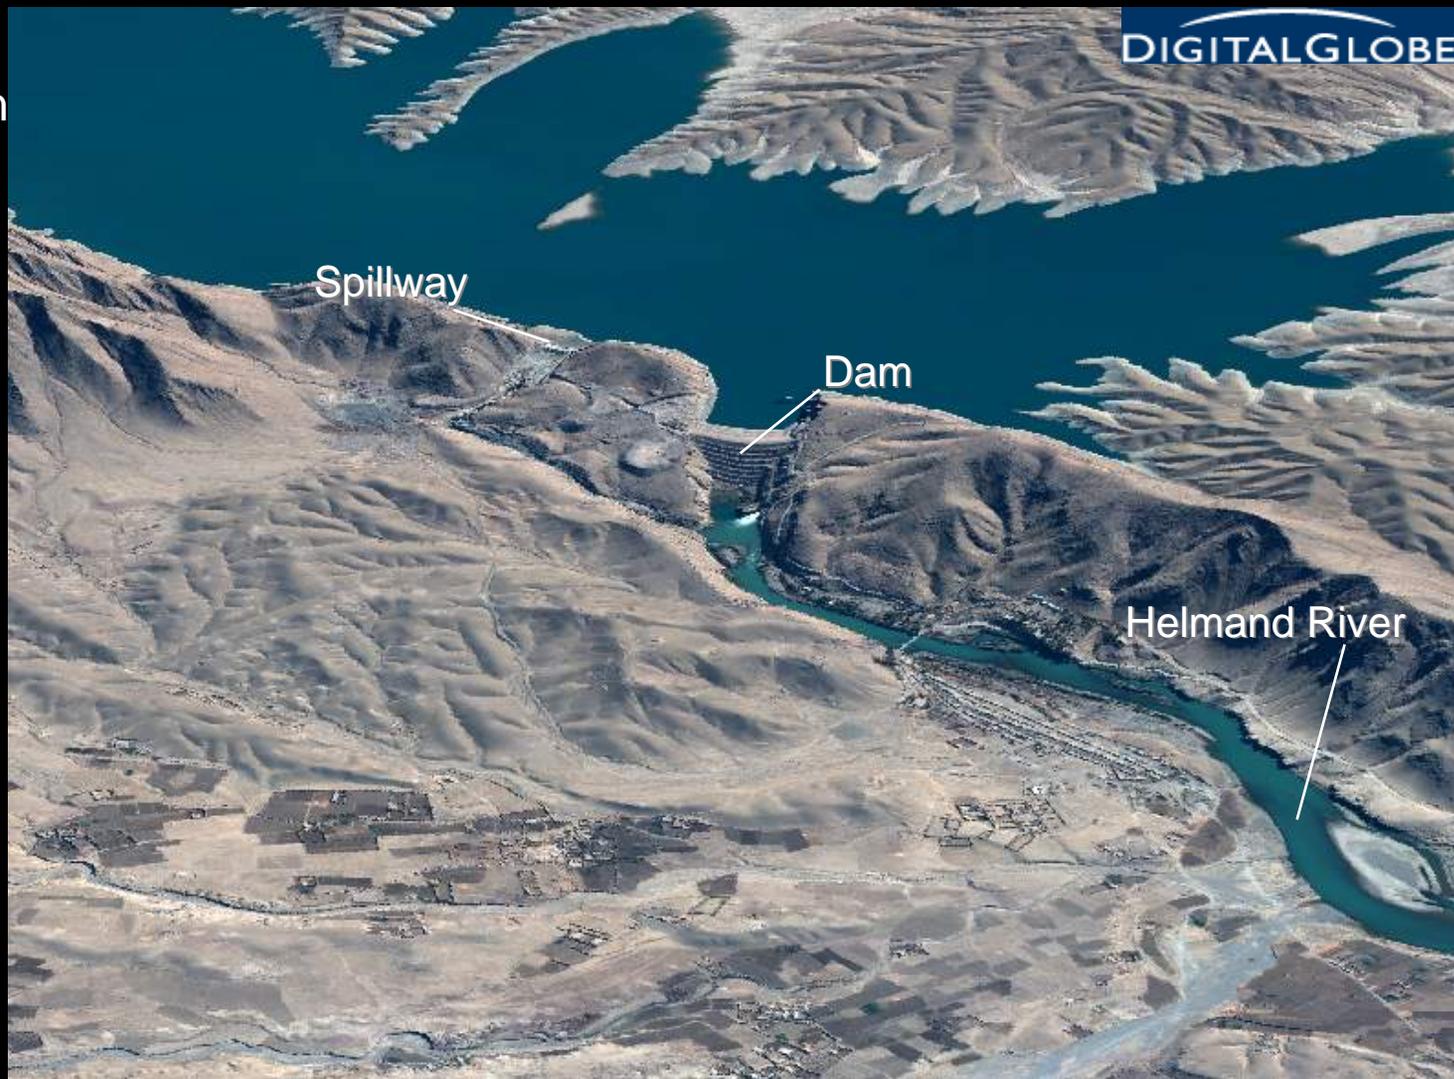
Kajakai Dam and Spillway Level Increase

- Terrain Visualization of Kajakai Dam

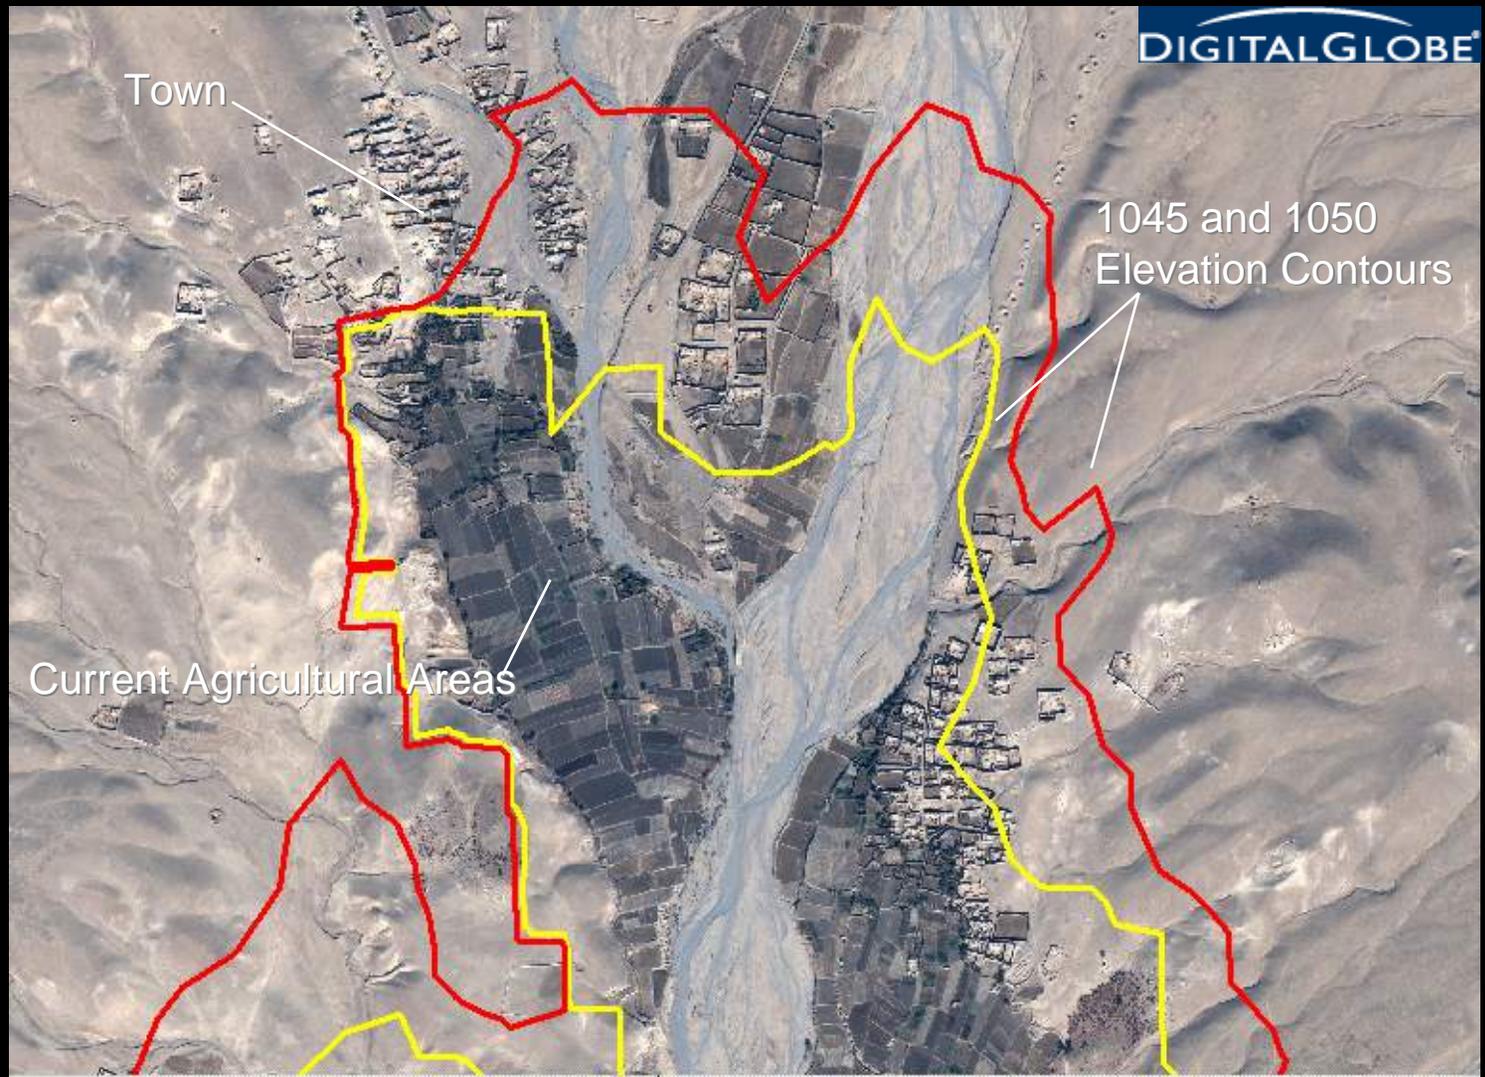
Kajakai Dam and Spillway Level Increase: SRTM Elevation Data

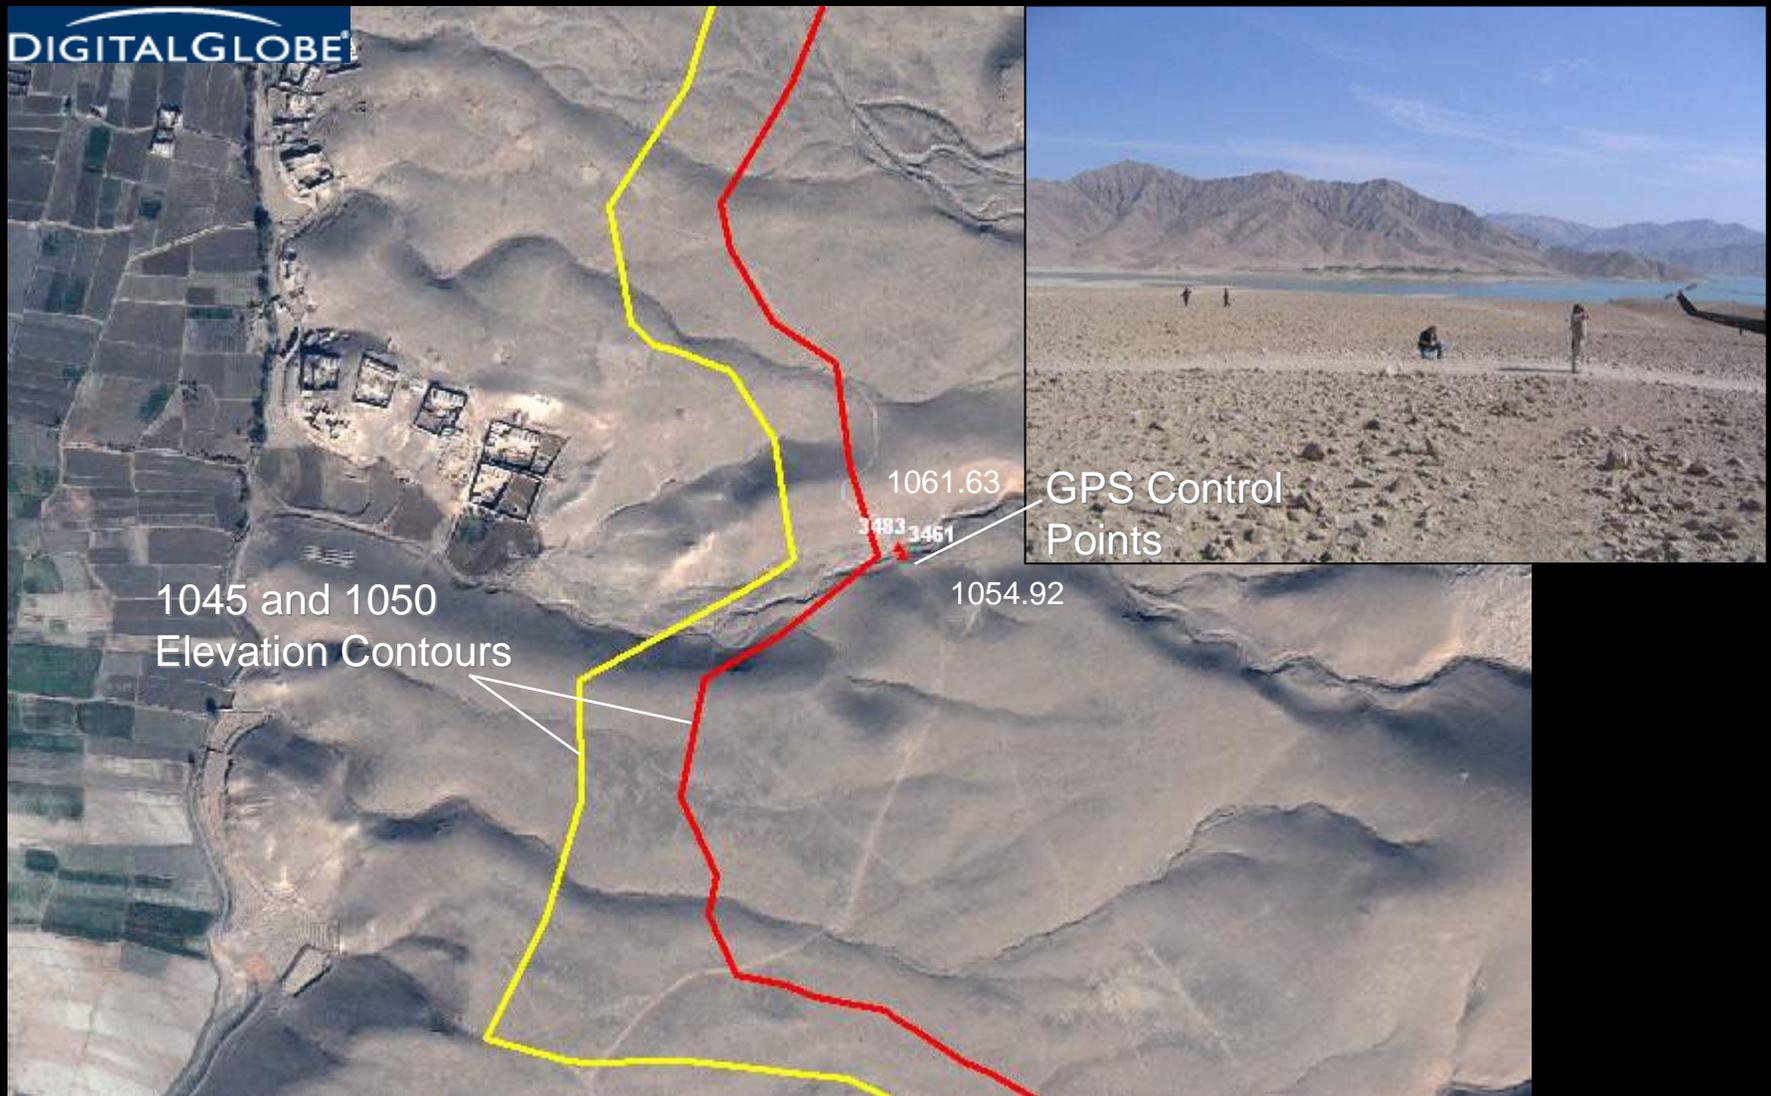
Need for More Accurate and Refined Elevation Model

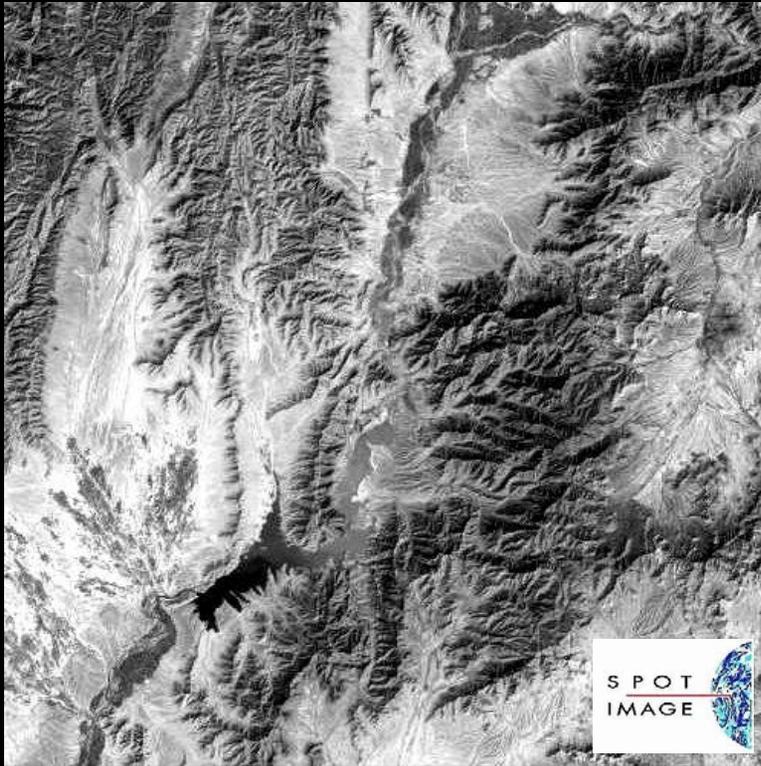
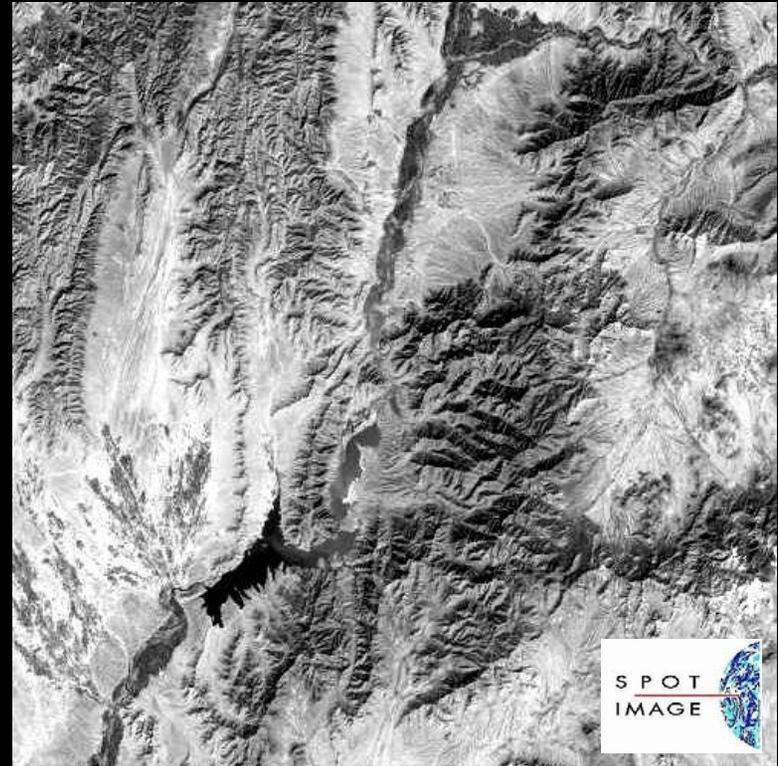
SPOT5 2.5m Resolution Panchromatic Image Stereo Collection

Image date 02/26/06

Image date 02/27/06

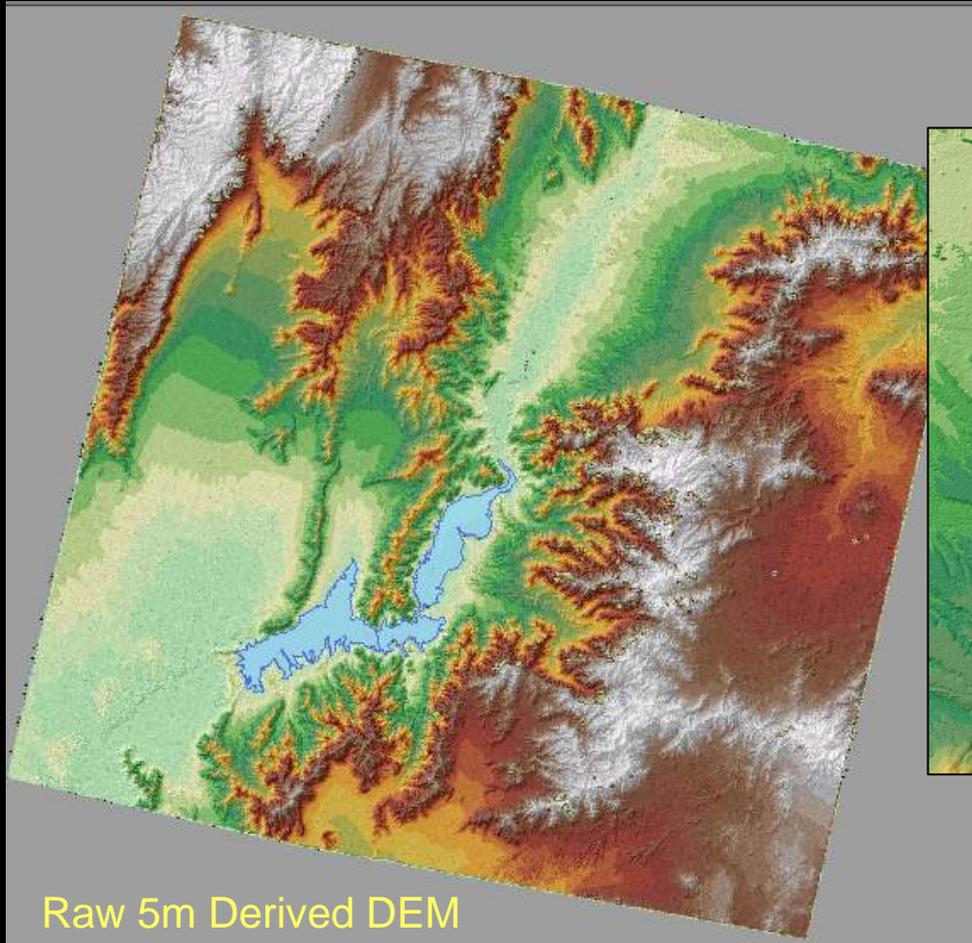
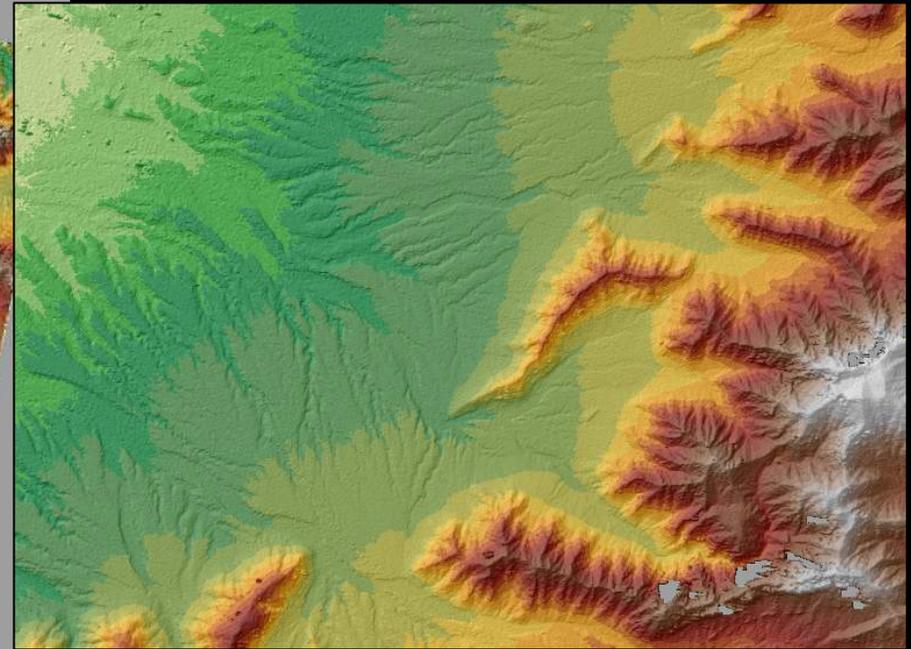
SPOT Derived 5m Resolution DEM

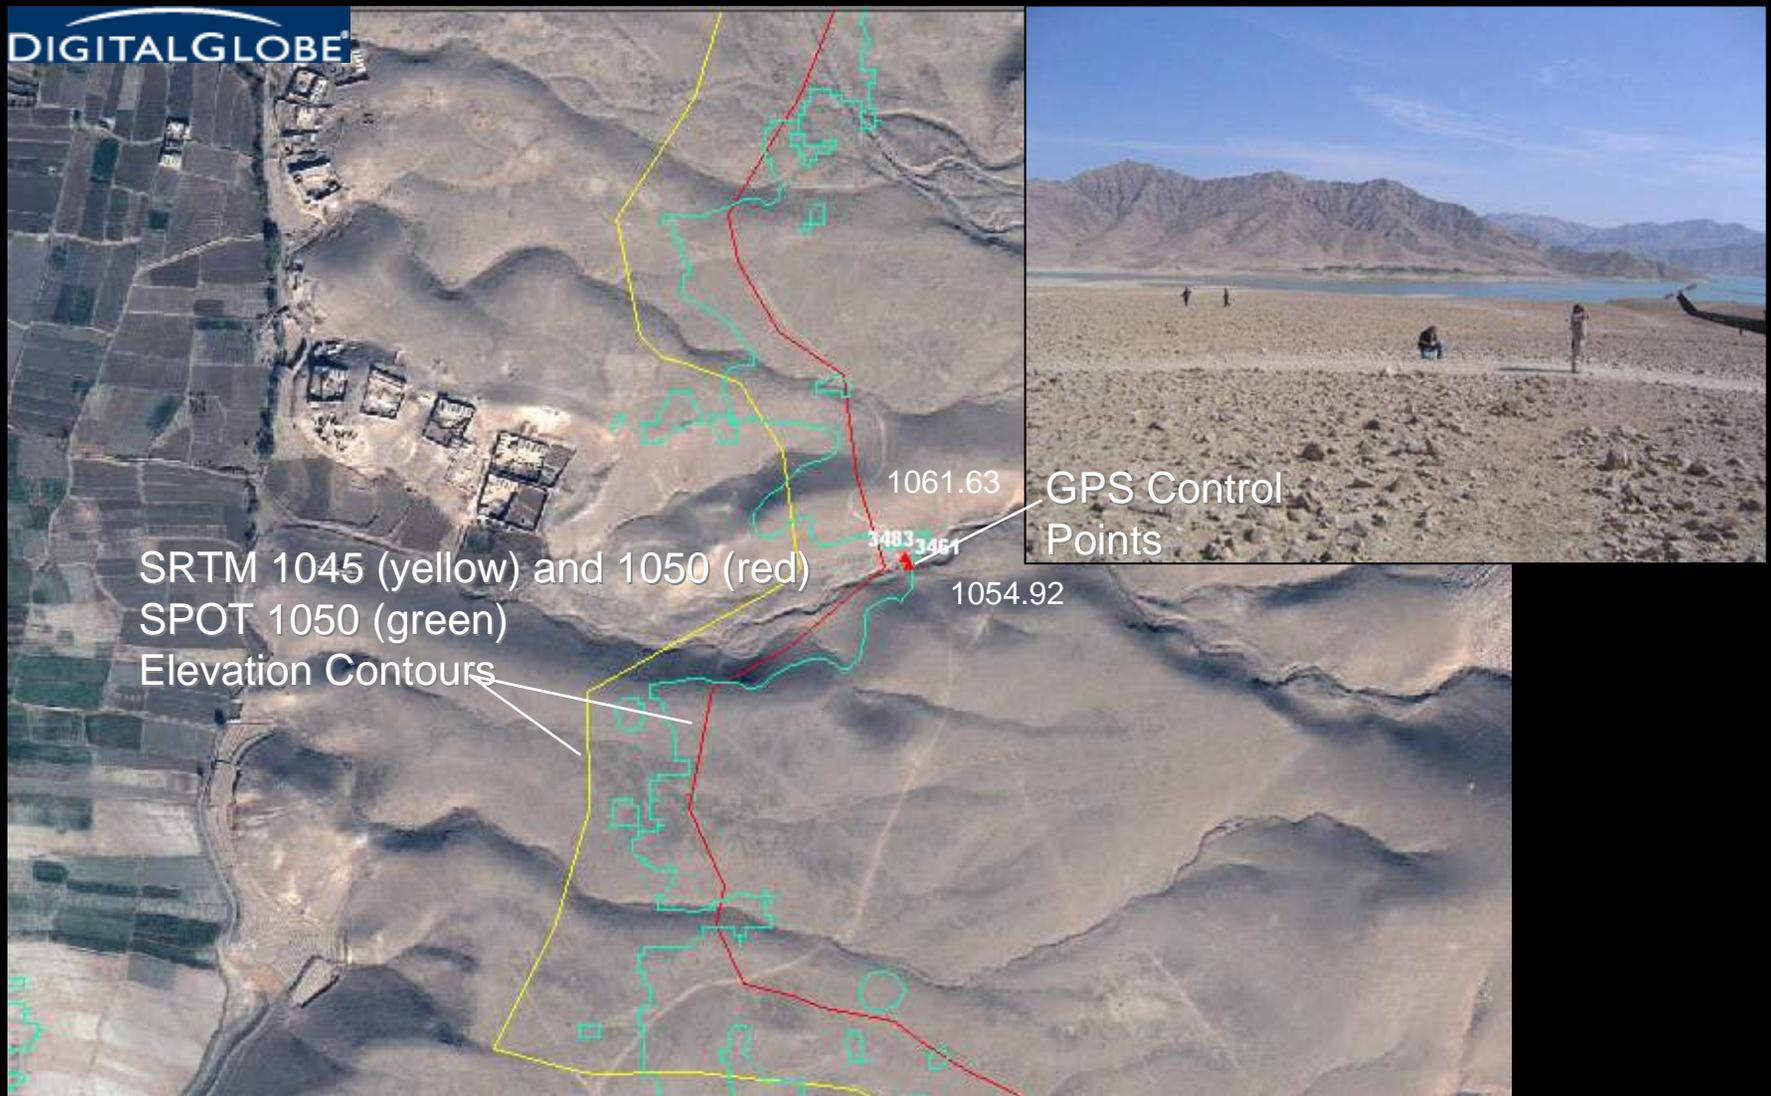
Qualitative Elevation Comparison Results

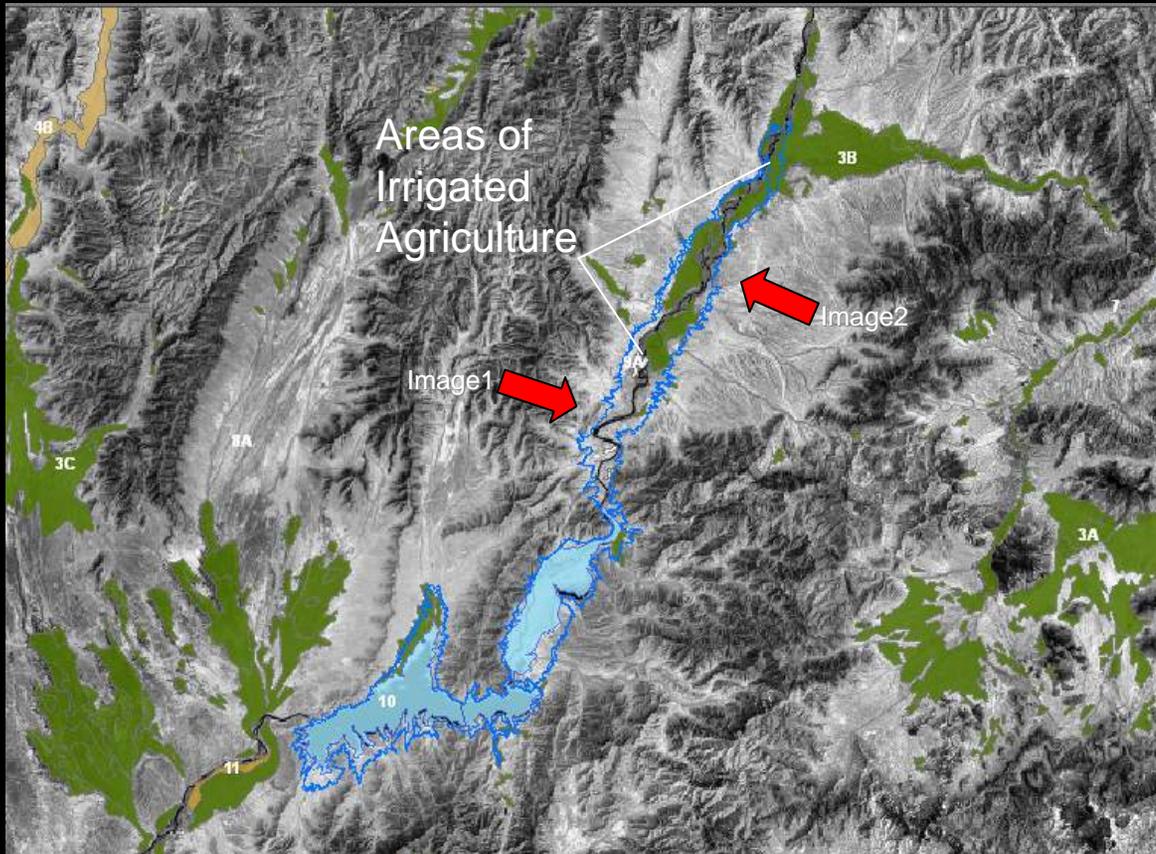
New Reservoir Impact to Landuse/Landcover
