# Definition of KOMPSAT-3 Product Quality

March 27, 2014

<sup>a</sup> Korea Aerospace Research Institute (KARI)

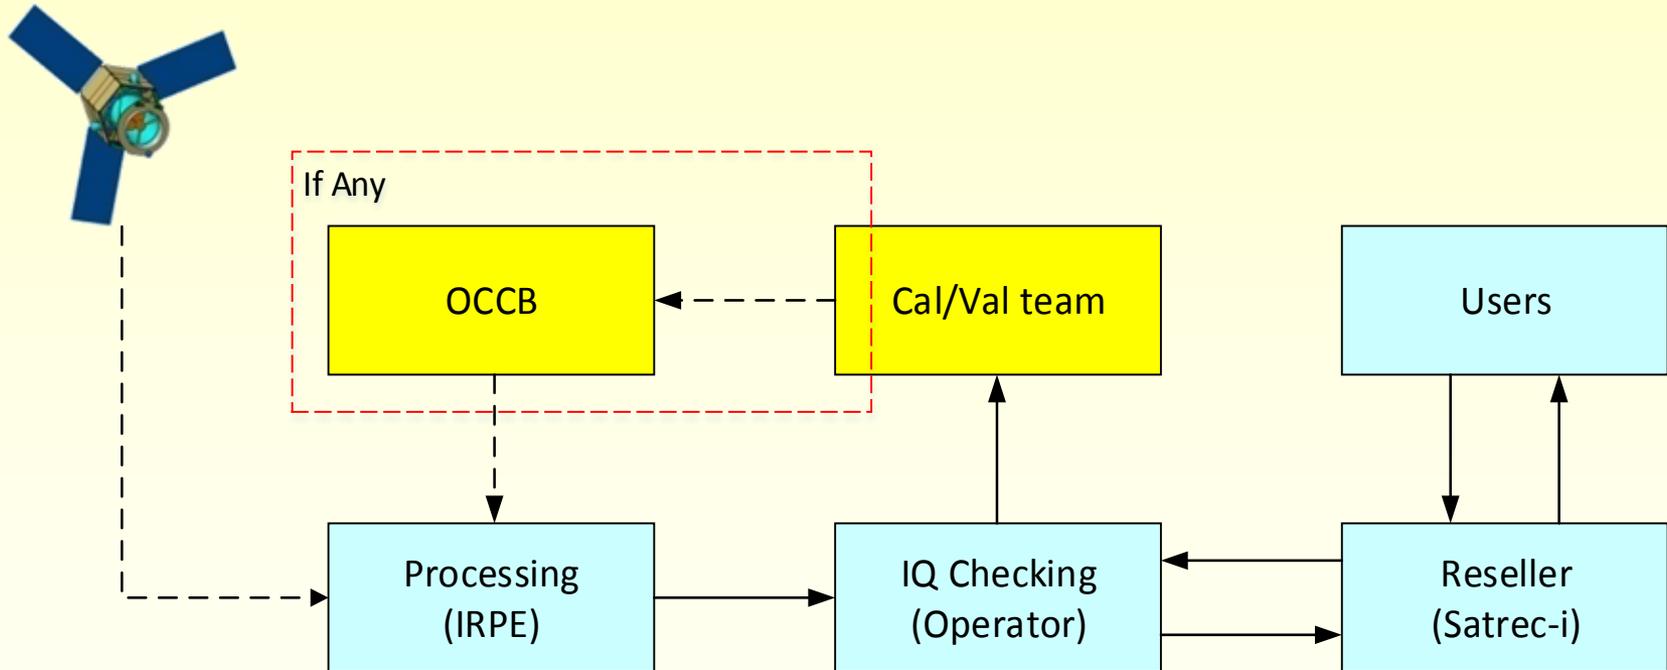
- Regularly Processing & IQ Checking by Operator
- Regularly Monitoring by Cal/Val team
- If any IQ issues, report to OCCB by Cal/Val team
- According to the OCCB procedure, carrying out it

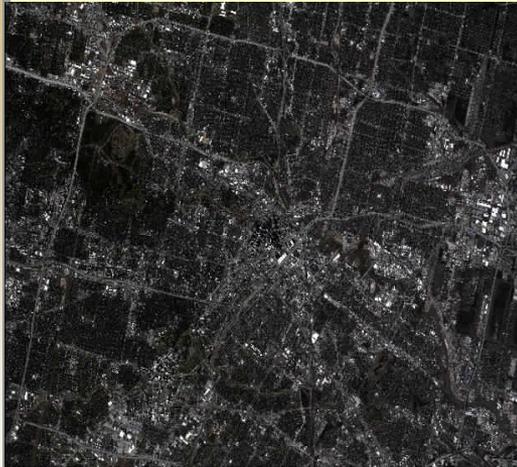
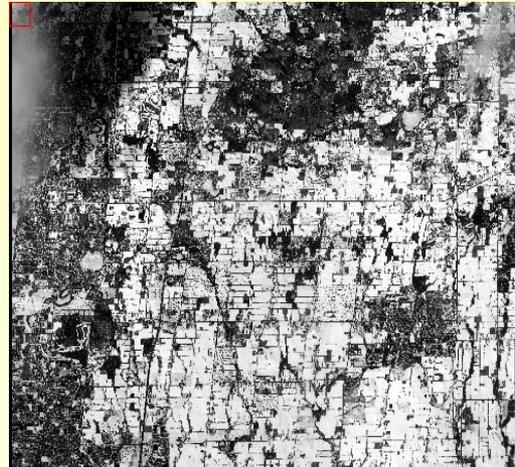
Anomalies Image	Constraint (TBR)		
	Level 1	Level 2	Level 3
Dynamic range (0 ~ 16363)	> 1000	500~1000	< 500

K3\_20130110191806\_03480\_18511222\_L1R

K3\_20130310175432\_04341\_19881329\_L1R

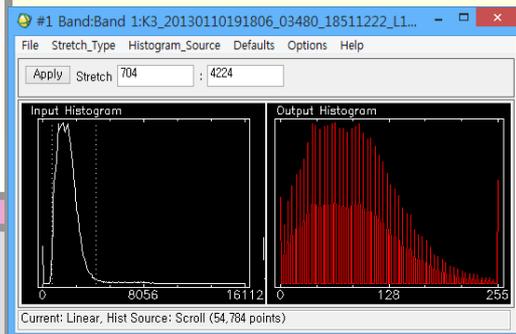
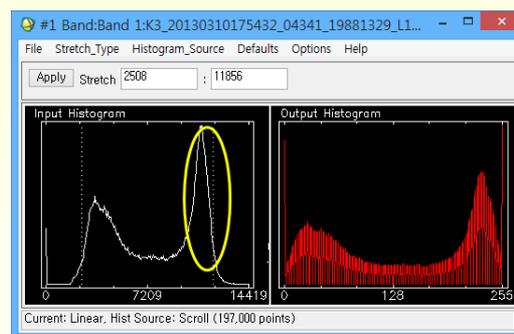
Histogram of Linear 2% in Scroll window in ENVI

- Linear 2% in Scroll window in ENVI (TBR)
  - ✓ DN(Max – Min)
  - ✓ “3500” = 4224 - 704
- Except the next area
  - ✓ Uniform bright area
  - ✓ Forest, Farm, Desert, Ice, Mountain, Big river, Big lake, etc.
  - ✓ Snow, Cloud, Ocean, etc.
- Only ROI requested by User
- ❖ User want a sufficient dynamic range in the satellite radiometric resolution.
  - ✓ KOMPSAT-3: 14bit
  - ✓ 0 ~ 16383
  - ✓ Not stretching in the Processing system

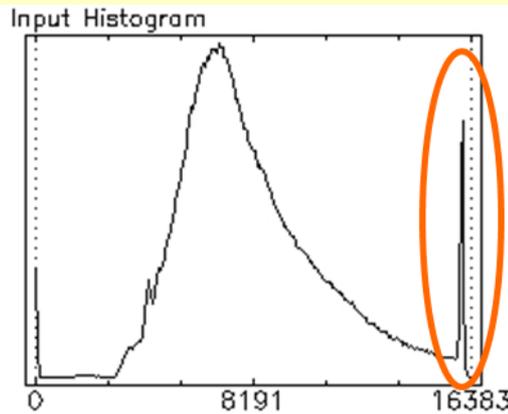
MS Green band: Saturation in SF (2012.06.05)

- Basically, >16383 DN, but
  - ✓ The Saturated area has a width of DN after the Processing system
- Except the next area
  - ✓ Snow, Ice, Cloud, Salt desert, etc.
- Only ROI requested by User
- ❖ User never want a saturated image data product.
  - ✓ Several exposures of Satellite be needed according to the imaging area.
  - ✓ KOMPSAT-3 has Two TDI stages.
  - ✓ KOMPSAT-3 data collection planning system has a Radiance (Reflectance) calculating module in Worldwide.

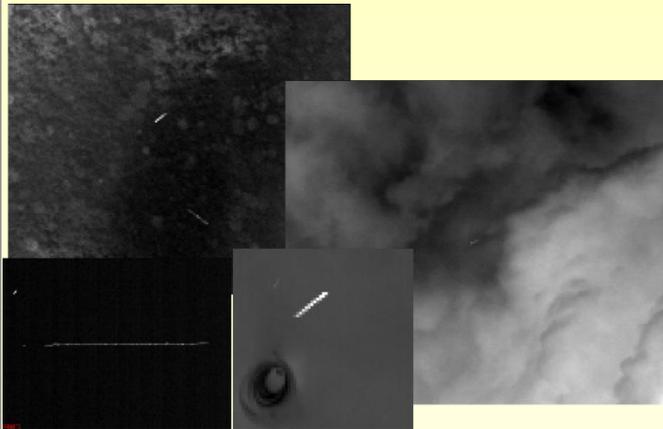
Speckle noise in MS

- Abnormal DN of any Pixel
  - ✓ (ex.) Speckle noise
  - ✓ Number of Abnormal parts in a image data product
  - ✓ Not number of abnormal pixels
- Except Blooming
  - ✓ But, in case of Big and Large blooming, KARI Cal/Val team will inspect it.
  - ✓ (ex) Left bottom figure.
  - ✓ (TDI CCD)
- ❖ User don't want the Abnormal pixel
  - ✓ User needs the location of the Abnormal pixel.

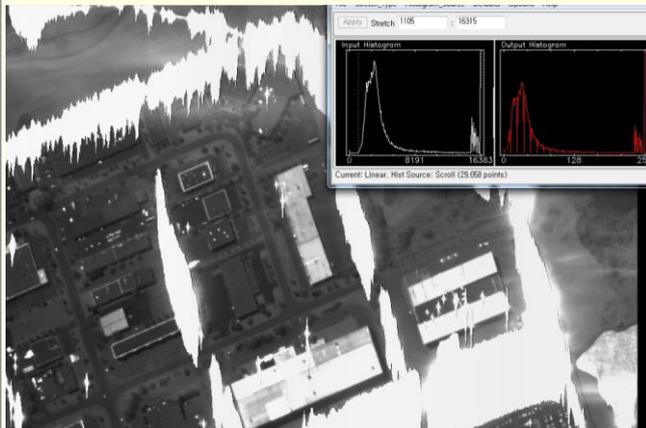
20130513031053\_05267\_024\_P7

Large Blooming by the direct solar incidence reflection

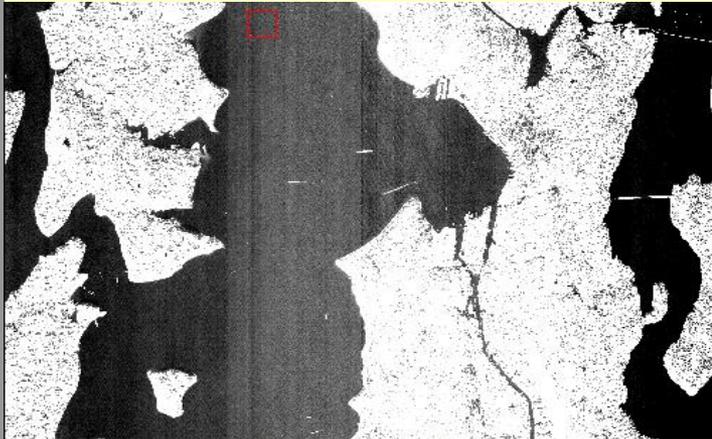
K3\_20130103212714\_03379\_17041356\_L1R\_P

- At less than around 1500DN, NUC is NOK.
  - ✓ Different DN range per each Band
  - ✓ Lake, Ocean, River, Dark Shadow, etc.
- RNUC module in IRPE PMS has been Ready
  - ✓ Updated RNUC table
- ❖ One of the main purpose of the High resolution image data product is 'detecting and recognizing' on a Land area.
  - ✓ but, User also want clear image in the coast and lake area.

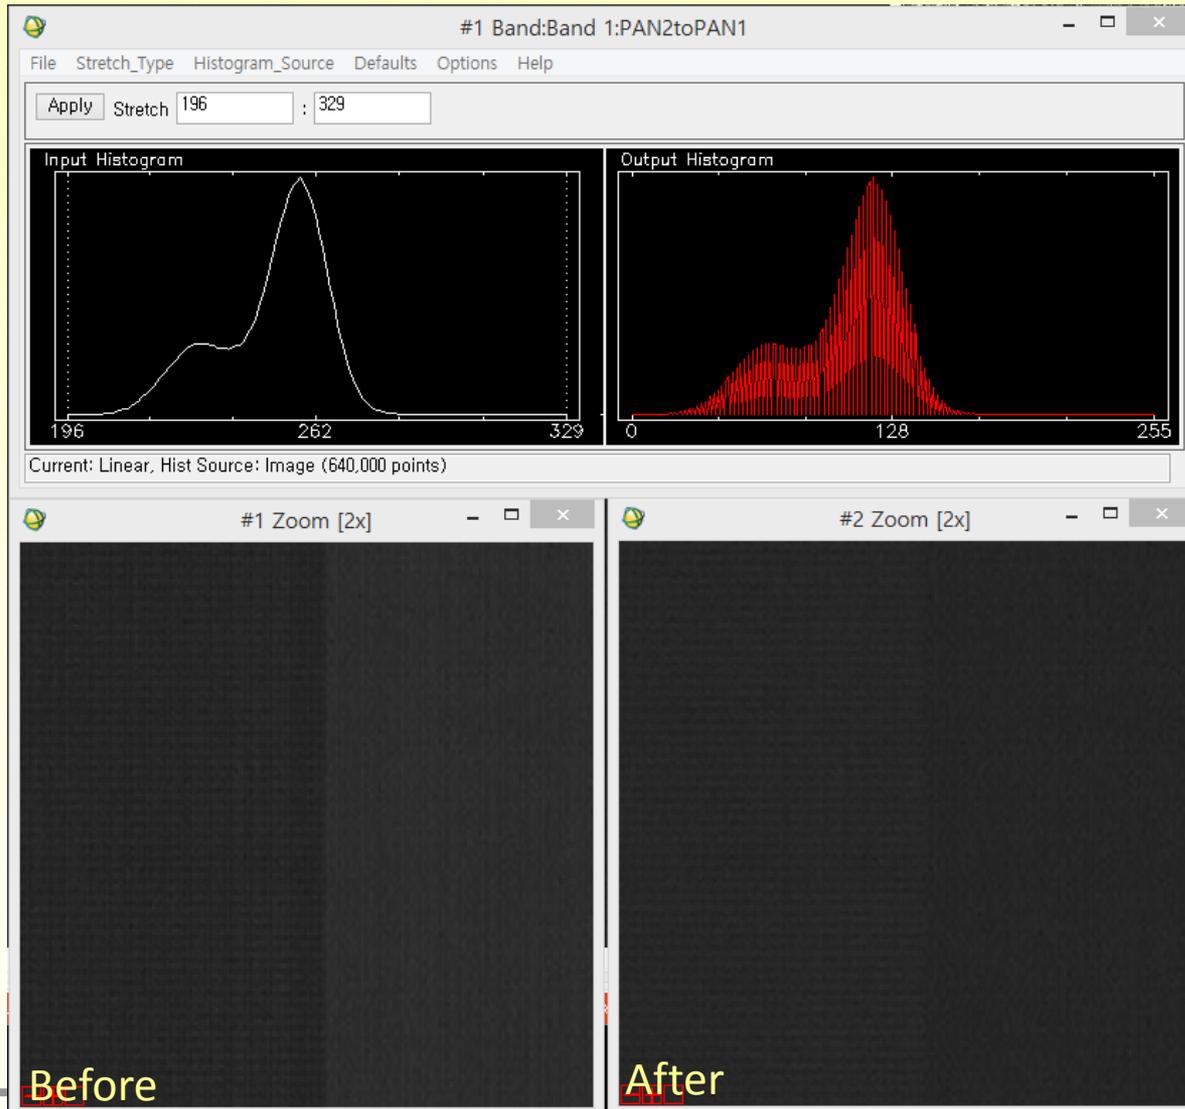
CALL0F\_121115181118\_02661 (PAN)

# Updated RNUC table (Additional Cal/Val item)

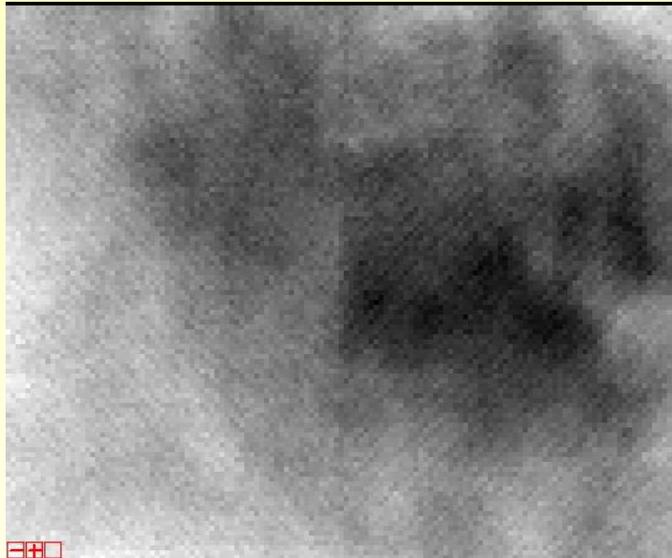
Diagonal noise in MS Green

- KOMPSAT-3 Radiometric resolution is '14 bit'
- The background noise level is '15 DN'
- ❖ User may be difficult to determine any information by the pattern noise.
  - ✓ A rough de-noising may reduce and remove any information.
  - ✓ So, the optimized de-noising for KOMPSAT-3 has been applied.

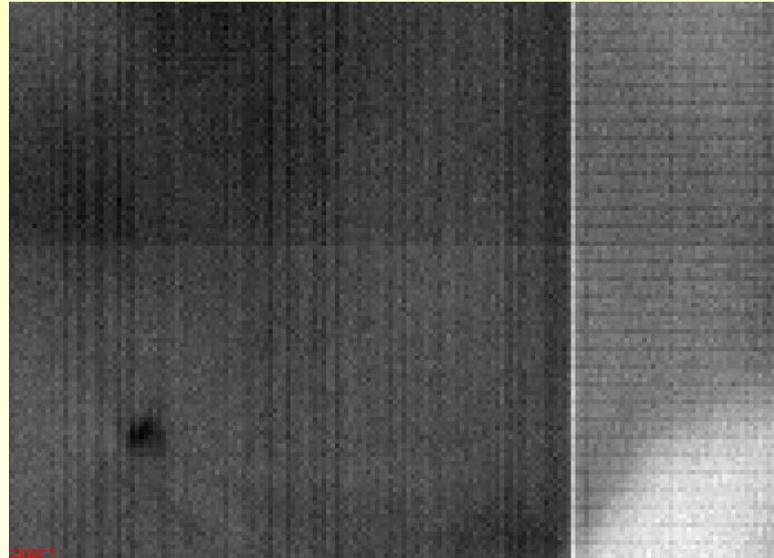
Vertical, Horizontal, First pixel noise in PAN

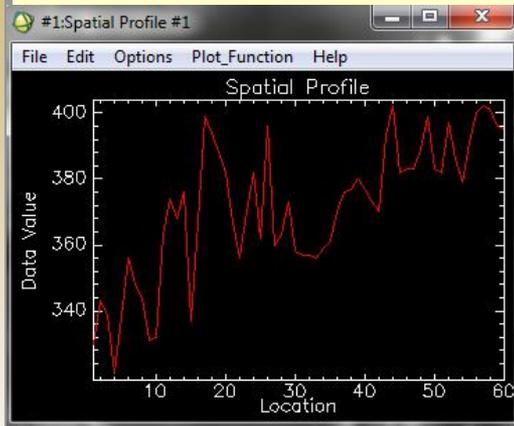
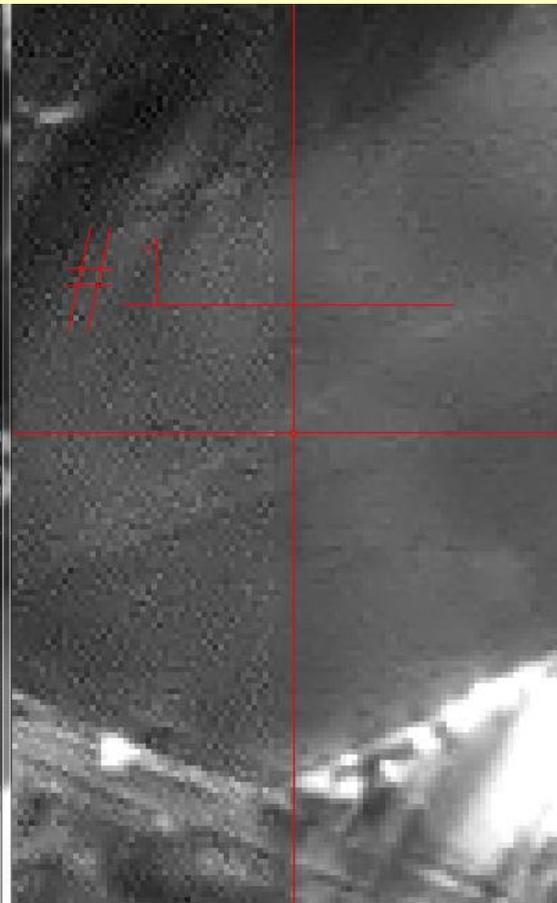
# Pattern noise (Center pattern difference )

- The noise on Each detector is different
  - ✓ Pattern noise
  - ✓ Compression noise
  - ✓ RNUC
- ❖ User don't want any noise
  - ✓ The optimized de-noising for KOMPSAT-3 has been applied.

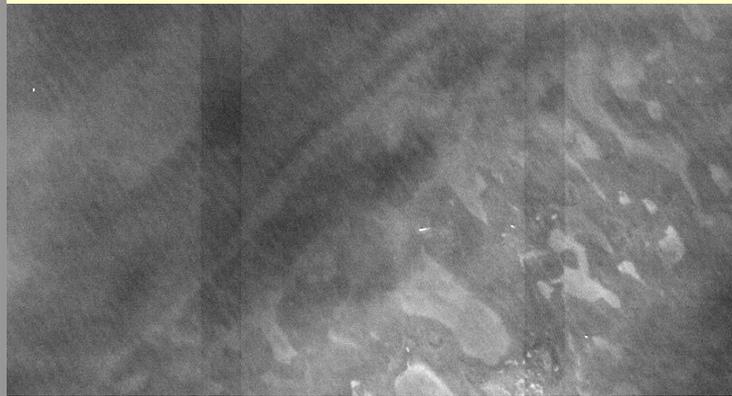
Pixel burst in K3\_20130205112349\_03855\_02531233\_L1R\_B

- Only MS band
  - ✓ Width of Pixel burst is '50 pixel'
  - ✓ Width of Port Diff is '300~1500'
  - ✓ DN difference is '20~50 DN'
- ❖ User don't want any noise
  - ✓ The optimized de-noising for KOMPSAT-3 has been applied.

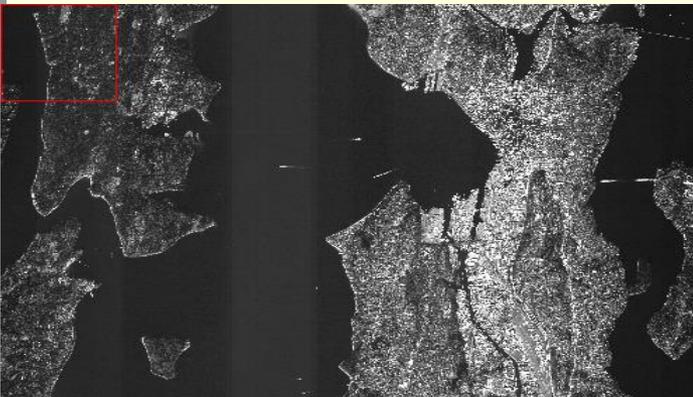
Port difference in K3\_20130103212714\_03379\_17041356\_L1R\_B

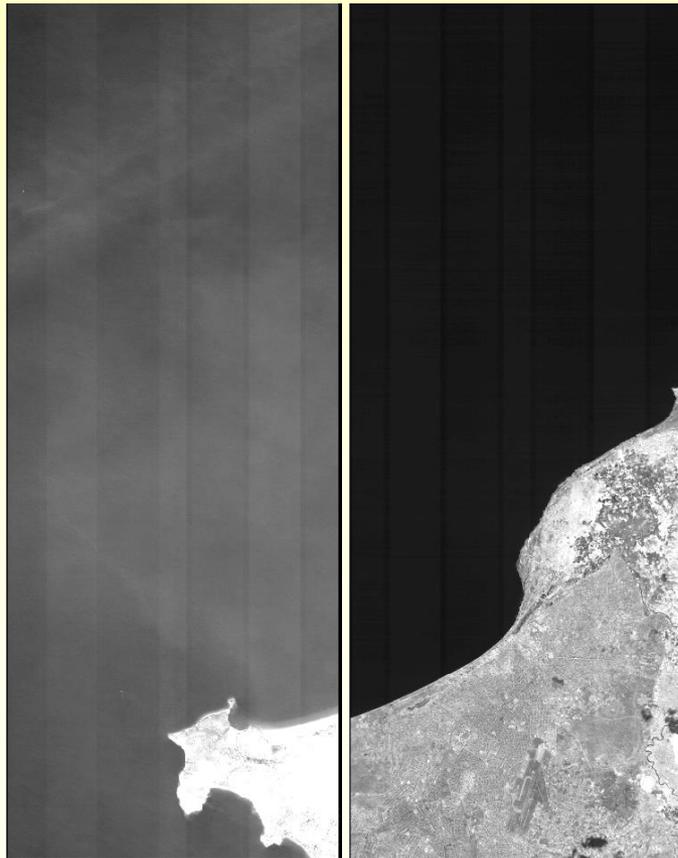
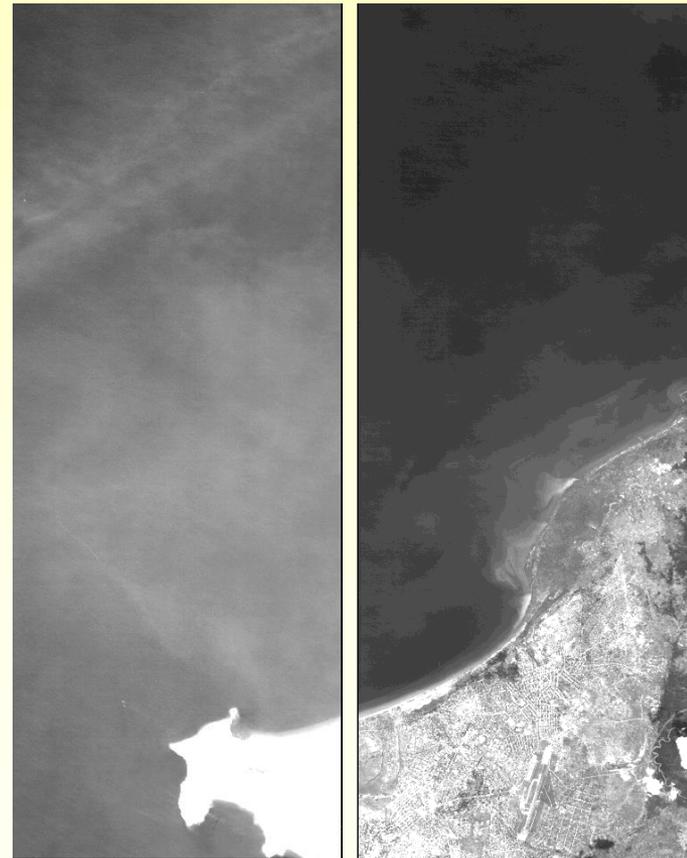
CALL0F\_20120616032915\_00432\_024 (MS Green)

# Reducing Pixel burst (Additional Cal/Val item)

Before

After

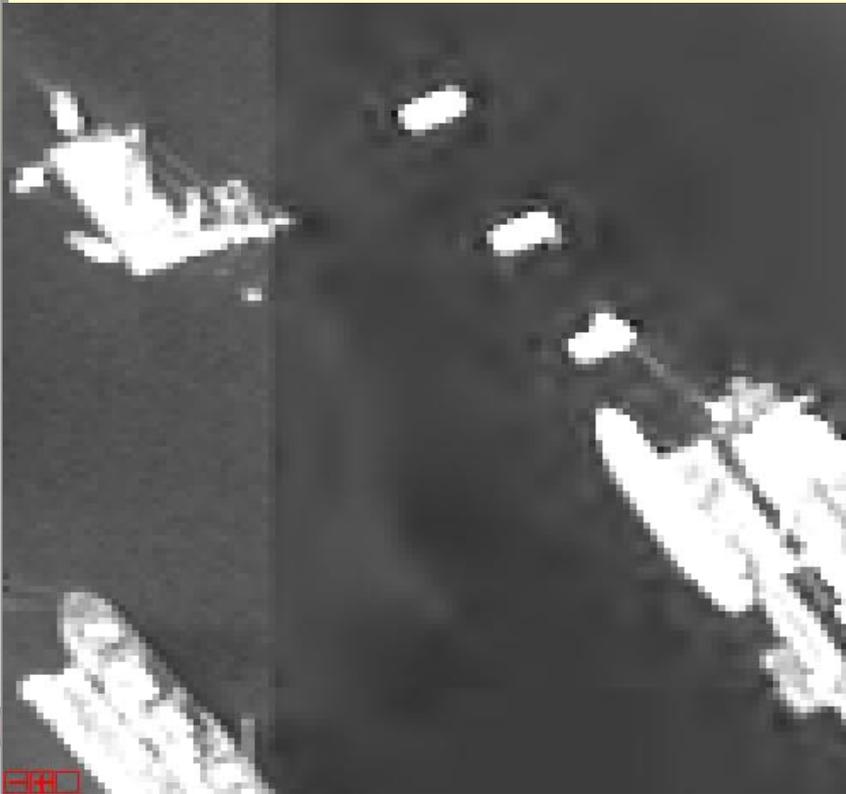
K3\_20130210093832\_03927\_04161188\_L1R\_B

- Compression ratio is '5.5' by CCSDS 122.0-B-1 (Wavelet)
  - ✓ PAN has a little
  - ✓ MS has many
  - ✓ Uniform area nearby high frequency area in city
- ❖ User don't want the compression noise
  - ✓ KOMPSAT-3 has been changed
    - PAN: '5.5'
    - MS: '3'
  - ✓ KOMPSAT-3 has little compression noise with the Compression ratio '3'.

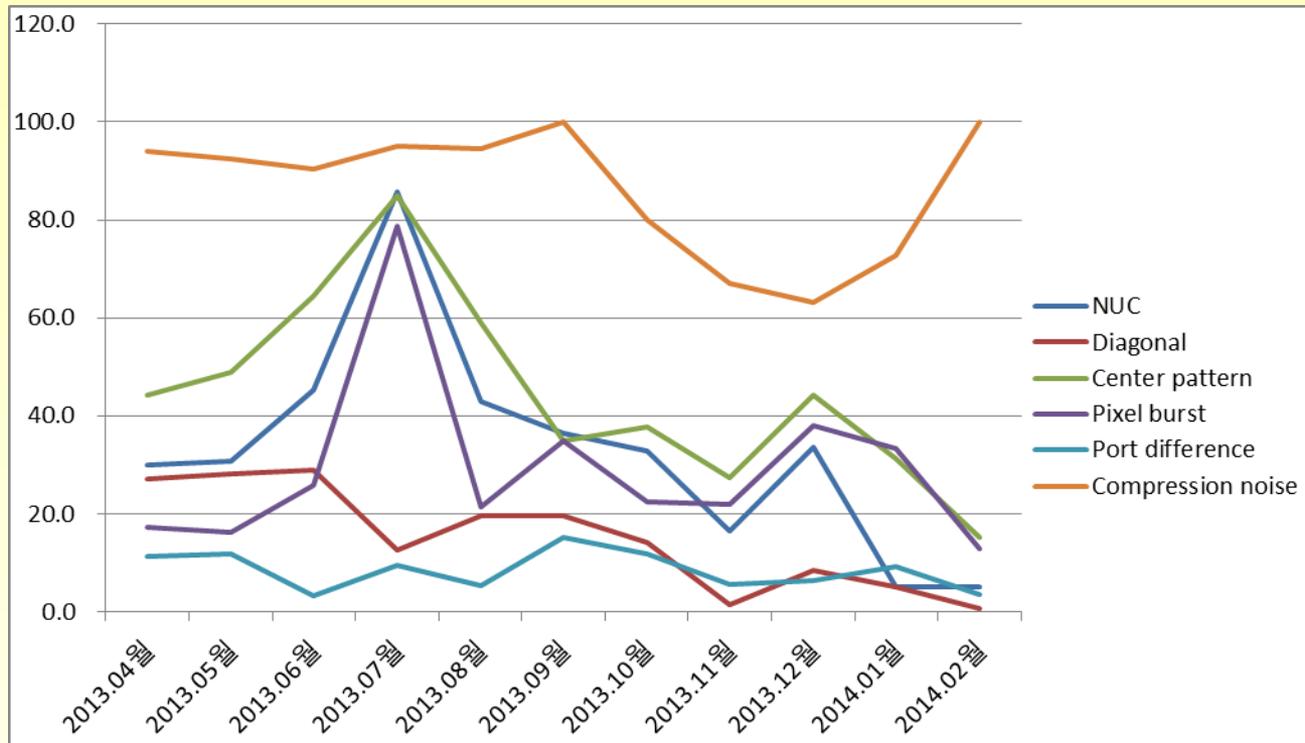
# Monitoring of KOMPSAT-3 Product Quality

- Reducing the Noise from Jan. 2014 after applying the additional Cal/Val
- But, Compression noise is still high.
  - ✓ Because User(reseller) can choose the Compression ratio and still use '5.5' for MS image data.
